MARINE INVESTIGATION REPORT

M02W0147

CAPSIZING AND LOSS OF LIFE

SMALL FISHING VESSEL *CAP ROUGE II*

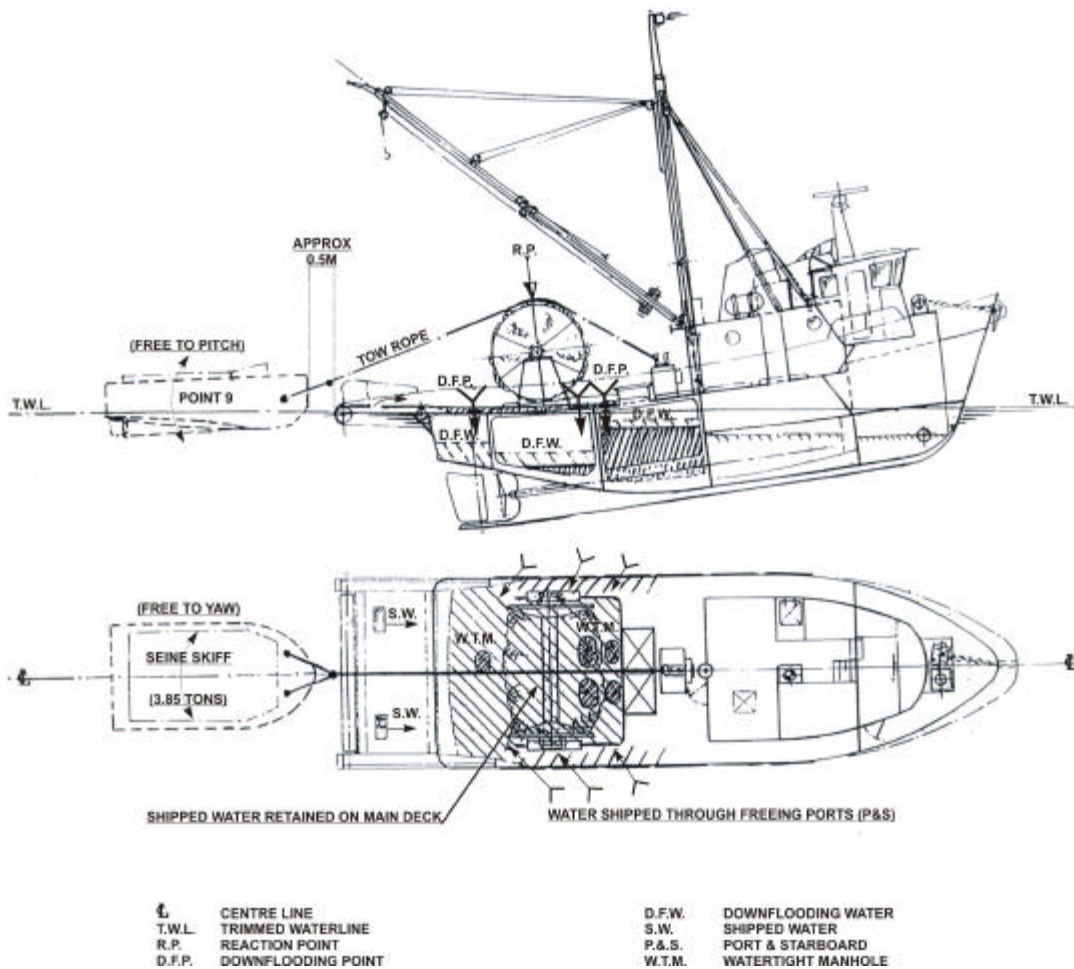
Due to the wave pattern generated by the speed of the vessel through the water and the rolling and pitching motions in the prevailing confused sea conditions, water was shipped through the freeing ports at main deck level and also through openings in the fixed stern ramp. As the shipped water accumulated at the after end of the main deck, it was constrained within the area bounded by the seine net drum seating and the forward fish pen and hatch coaming. Because the gaskets of the manhole covers of the four fish holds and the lazarette were ineffective, downflooding into all of these compartments commenced (see Figure 3).

The accumulated water on deck, together with the downflooding of the lazarette and lightly loaded after holds, created a marked increase in free surface area and a corresponding reduction in transverse stability.

The additional weight and free surface effects of the shipped water increased the after trim to 1.22 m (4.0 ft), lowered the mean and after freeboards, and markedly lowered the transverse stability characteristics of the vessel. While in this condition, the GMt was reduced to 68 per cent of the minimum requirement and, more significantly, the maximum righting lever and dynamic stability were lowered to 19 per cent and 10 per cent, respectively, of the recommended minimum values. Furthermore, the range of positive transverse stability was limited to an angle of 22° in lieu of the recommended range in excess of 40°.

Figure 3. Downflooding prior to capsizing

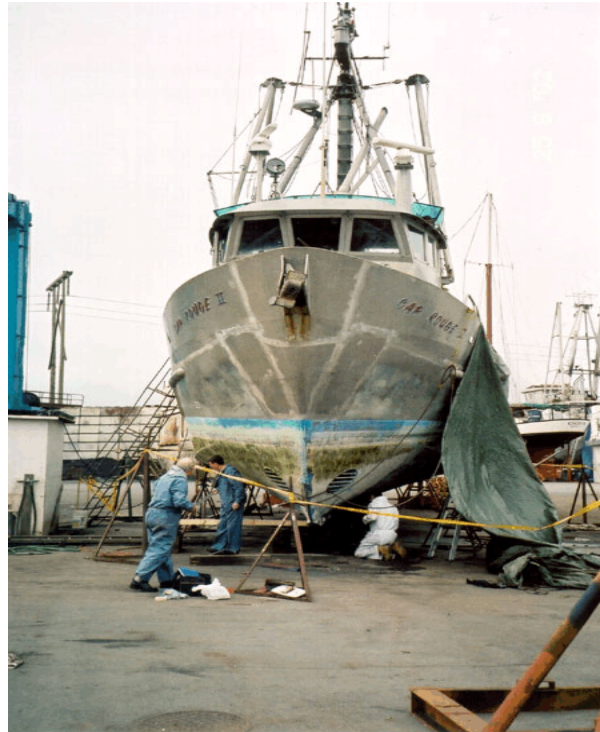
Photo 1. *Cap Rouge II* in dry-land storage, 10 days after being salvaged. 25 August 2002

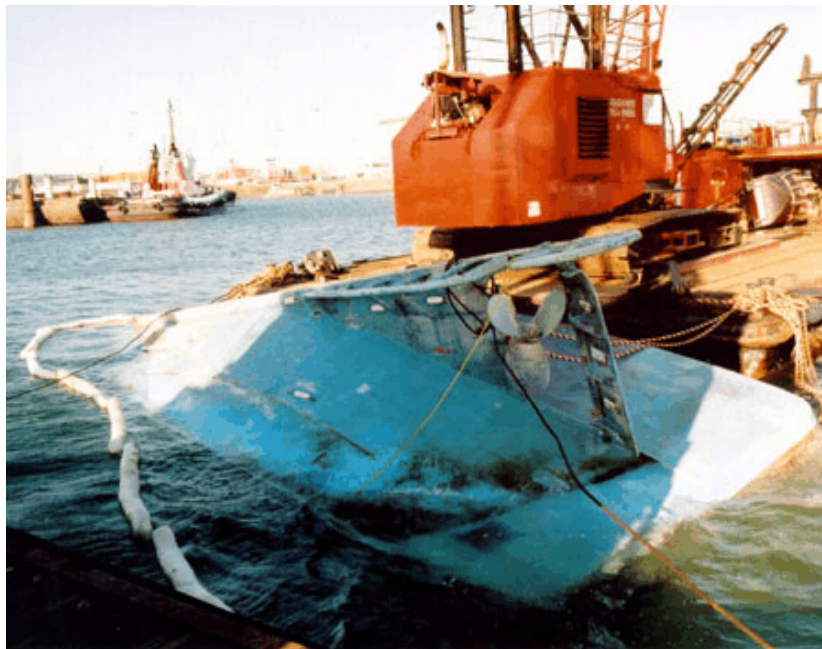
Photo 2. Capsized *Cap Rouge II* resting alongside salvage barge. 15 August 2002.

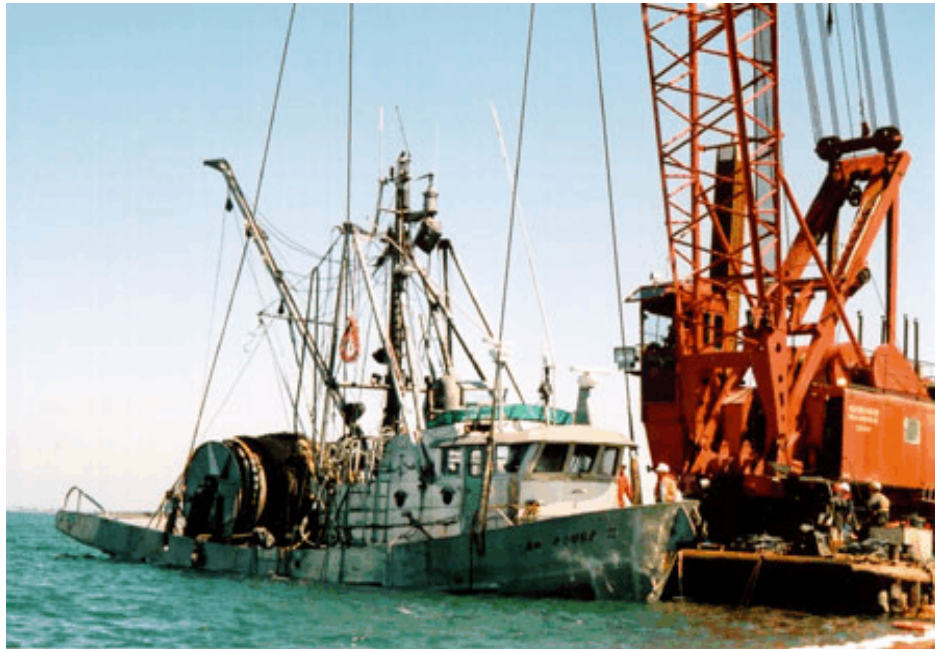
Photo 3. *Cap Rouge II* raised upright at the time of salvage

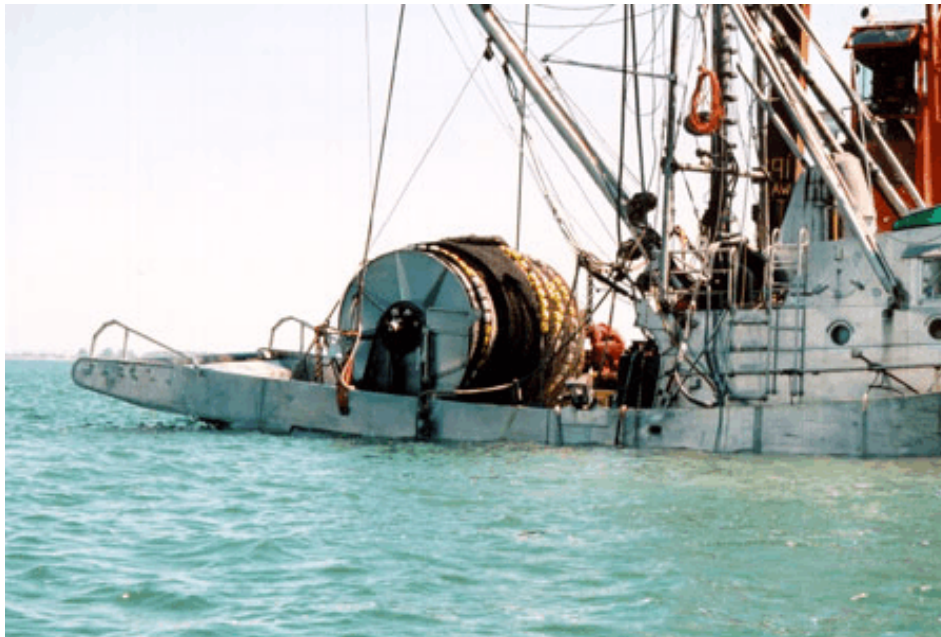
In this instance, a larger seine net was being employed, the weight of which was not verified until after the capsize, when it was found to be some 7.4 tonnes. This weight was somewhat heavier than the seine net usually carried, which weighed approximately 4.5 tonnes. The nets were routinely stowed on the power drum, located 1.75 m (5.67 ft) above the main deck, where their weight effectively raised the position of the vessel’s centre of gravity.

Photo 4. Working deck of *Cap Rouge II* showing west coast salmon seine net wrapped on net drum. 15 August 2002

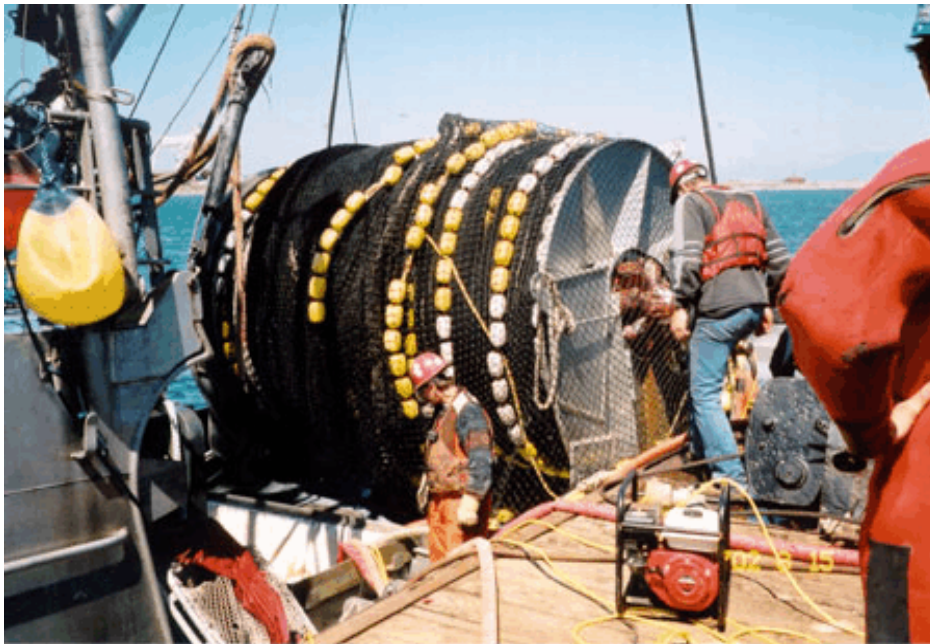
Photo 5. Close up view of seine net on the net drum. 15 August 2002

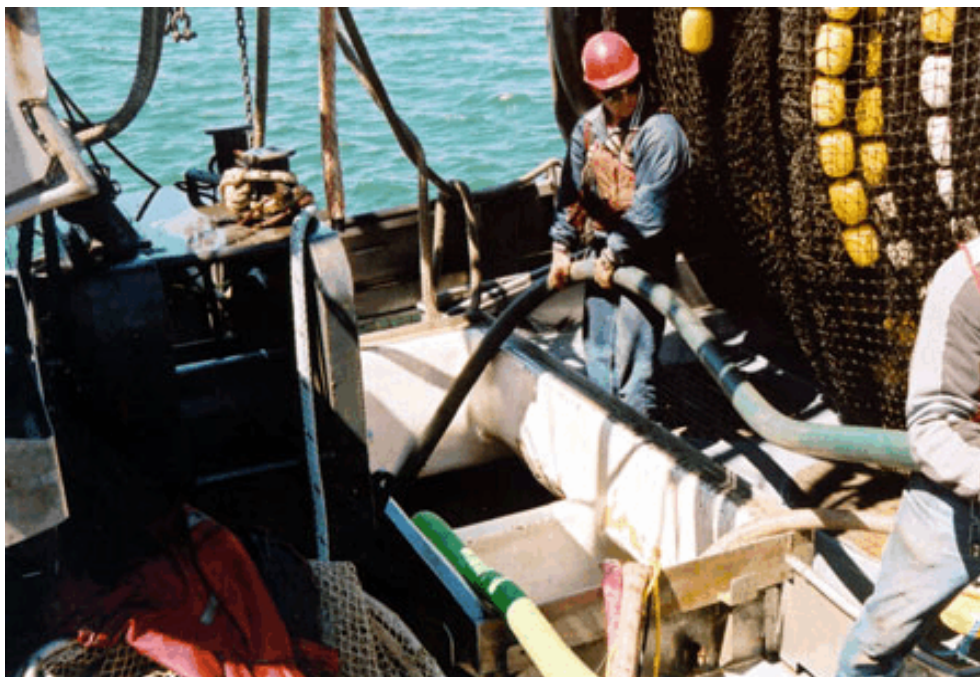
Photo 6. Portion of the forward fish holds being pumped dry by salvors.
15 August 2002

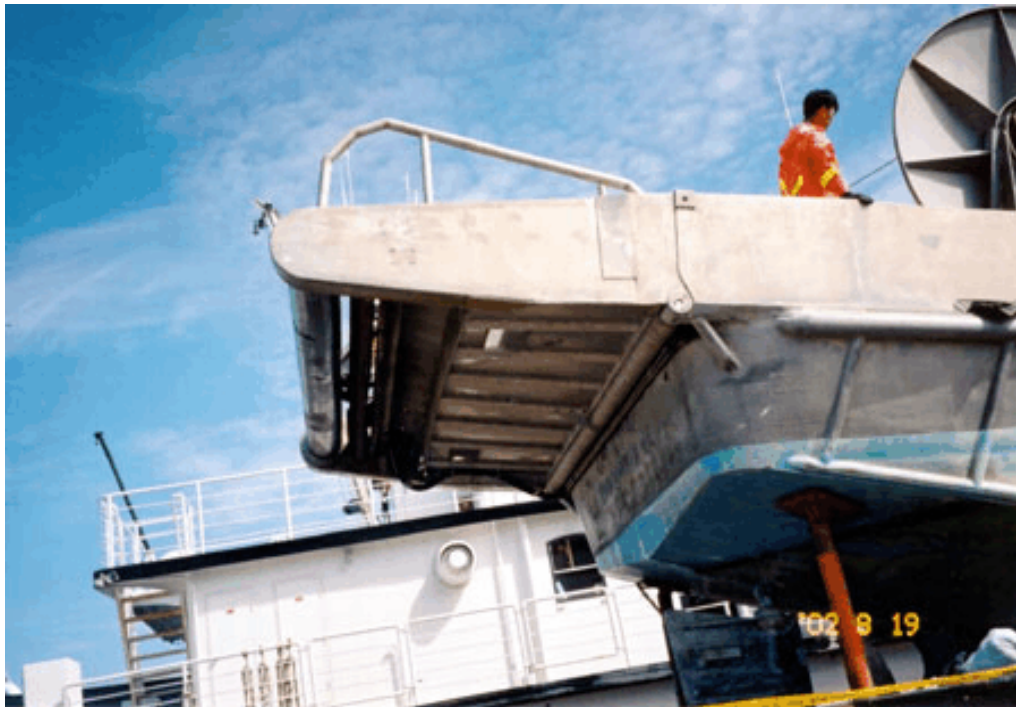
In the confused seas immediately prior to the capsize, when heavily trimmed by the stern and with a large heel to starboard, the *Cap Rouge II* was in an extremely vulnerable condition. At this time, a combination of relatively small additional heeling forces overcame the vessel's remaining righting ability and completed the capsize sequence. This combination included the yawing action of the downward force of the stretched tow rope of the seine skiff where it was led over the top of the seine net drum (see Figure 3), and the upward force of a wave acting on the port underside of the fixed stern ramp.

Photo 7. Stern of *Cap Rouge II* showing solidly constructed stern ramp extending beyond the transom. 19 August 2002

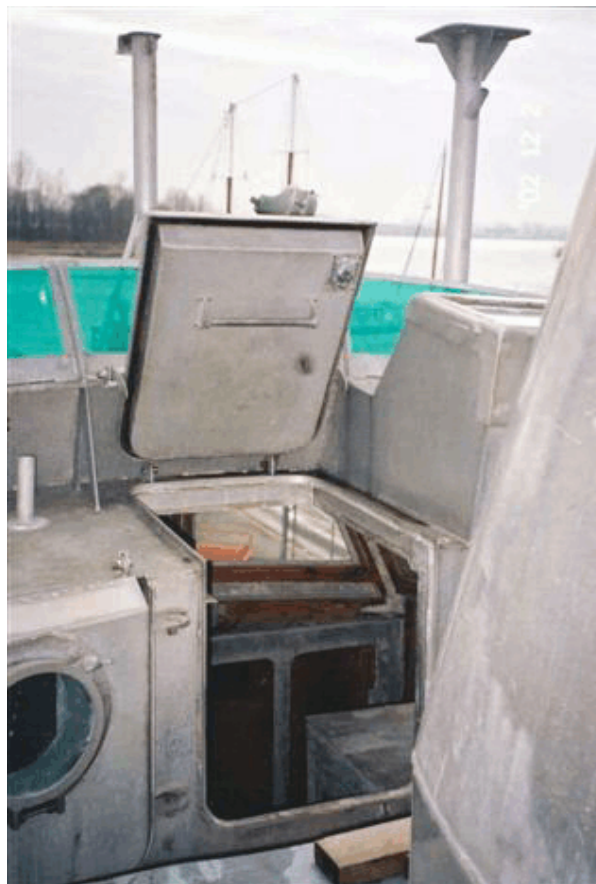
- the door on the starboard side of the wheelhouse was found closed by divers;
- the combined hinged hatch cover and door from the after end of the wheelhouse, giving access to the main deckhouse top, was found open by divers;

Photo 8. A combined hinged hatch cover and door on the centreline at the after end of the wheelhouse
